Intel[®] Pentium[®] III Xeon[™] Processor Specification Update

Release Date: March 2001

Order Number: 244460-027

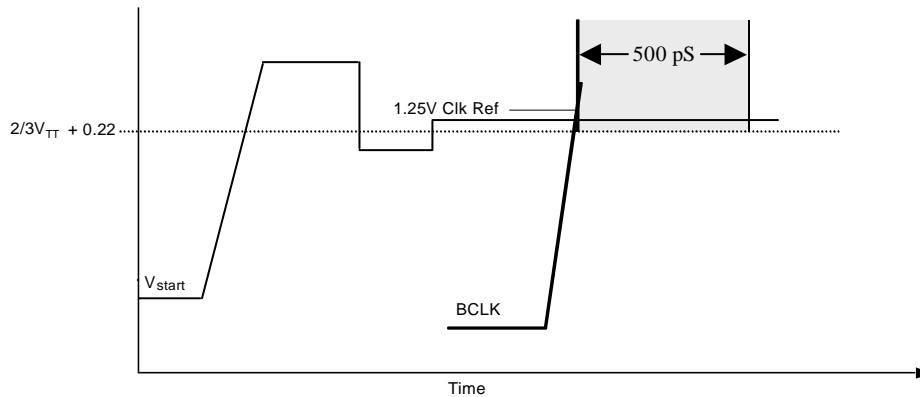
Intel has characterized the new AGTL+ AC specification for $V_{IH(MIN)}$ on the processor's RS0# signal to be: $(2/3 \cdot V_{TT}) + 0.22$ Volts within 500 picoseconds following the rising edge of BCLK crossing the 1.25-Volt threshold. See below.

Implication: The deviation from the published specification results in decreased noise margin on the RS0# processor input. This decreased noise margin has been observed to be particularly detrimental in system environments where the RS0# processor input is being driven by an I/O buffer with a pull-up device (such as a p-channel transistor) that is switched off mid-cycle. Systems that employ I/O buffers that keep the pull-up device on for the entire cycle are significantly less affected by this erratum. The reduction in noise margin may lead to the generation of BINIT# (when enabled) resulting in a system reset, otherwise this condition may lead to a system "hang" condition.

Workaround: If a system design cannot meet the specification deviation, the following areas should be carefully examined to assure that additional margin exists in order to compensate for any deficit observed with respect to the newly characterized $V_{IH(MIN)}$ specification:

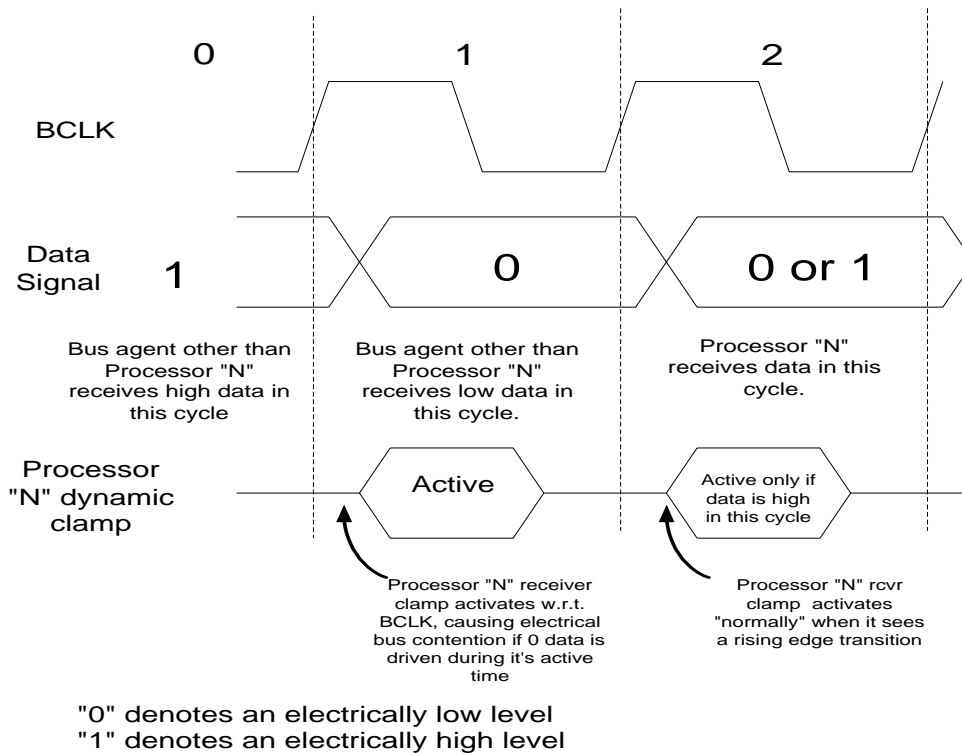
Problem: Falling edge ledge push-out and undershoot may be seen on AGTL+ data and data bus ECC signals. The AGTL+ receiver's dynamic clamp circuit activates (i.e. clamps the signal to an electrically high level) in certain cycles when data is driven to an electrically low level by another agent.

Implication: This erratum only occurs on a processor that does not receive data in that particular cycle. More specifically, this erratum only occurs when a specific processor does not receive data in the current BCLK period, but receives data in the very next period. Therefore, the processor inducing this falling edge noise (on data and data bus ECC signals) will not actually read the data in that cycle. See below for an illustration of this erratum affecting a processor denoted Processor "N". The falling edge ledges and undershoots may affect the signal quality and/or timing at agents that receive data in that cycle. Therefore, the impact of this erratum is highly dependent on system bus design.

Workaround: Evaluate system bus signal quality and timing margin at the valid receiving agent as a result of this falling edge noise. Due to dependence upon system bus design, bus layout may be evaluated to determine the need for improvements in signal quality and timing margin at the valid receiving agent as a result of this receiver-induced falling edge noise.
